Unreliable Airspeed at Takeoff

Since the beginning of 2020, Airbus has received an increasing number of reports of unreliable airspeed events at takeoff due to Pitot probe obstruction. Despite the existing prevention means and the preflight exterior walkaround, takeoffs with obstructed air data probes may happen. This article highlights why it is so important for pilots to actively monitor the airspeed during the entire takeoff roll, to detect an airspeed discrepancy as early as possible, and safely reject the takeoff, if required to do so.

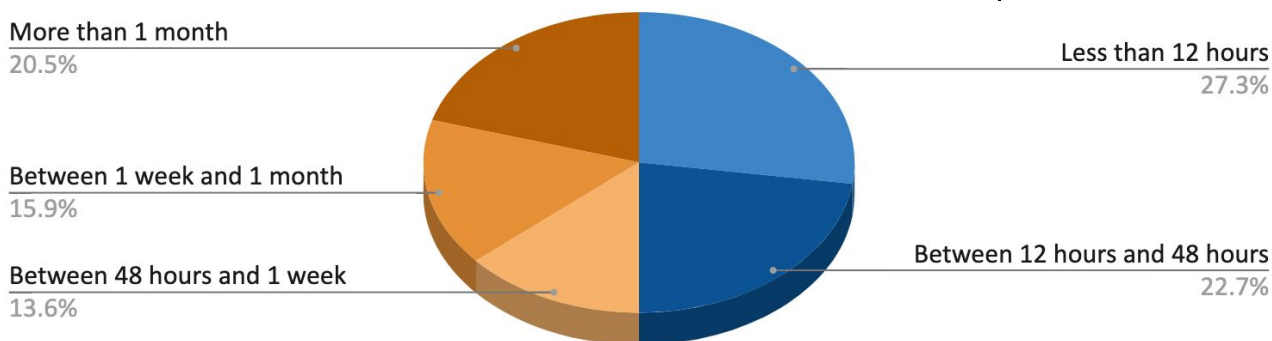
(fig.1) Duration of time an aircraft spent on ground before reported unreliable airspeed event

The chart below (**fig.1**) shows the duration of time an aircraft spent on the ground before the flight when the unreliable airspeed event occurred.

Contamination of Pitot probes by insects does not happen only during long periods of parking or storage. Half of all reported Pitot contamination related events occurs when the aircraft is parked for a time period of less than 48 hours. A significant number of reported occurrences of obstructed Pitots were on aircraft in transit and on the ground for less than two hours. Pitot probes are not always protected by covers during short duration transits.

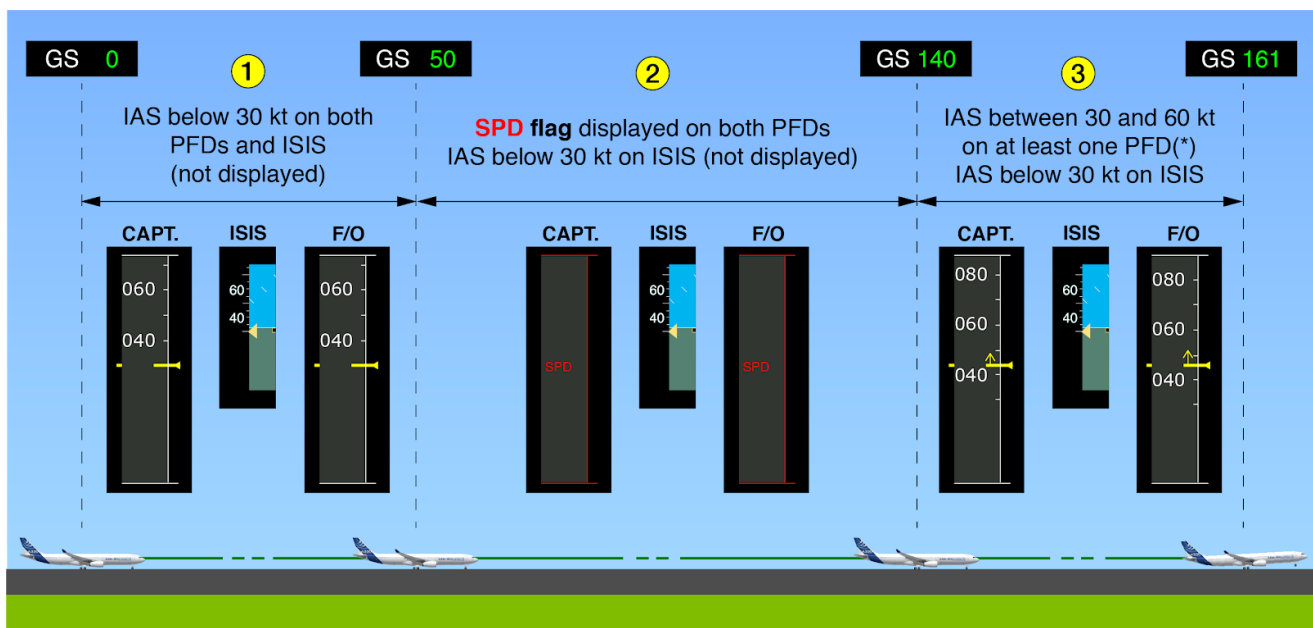
(fig.2) PFD airspeed indication during the takeoff roll of the event

Recorder data also showed that the display of the **SPD** red flag on both PFDs from 50 kt of ground speed should have made the flight crew aware of the airspeed issue which would have enabled them to reject the takeoff.

- **① From 0 kt to 50 kt of ground speed:** The Indicated Air Speed (IAS) was at the bottom of the speed scale on both PFDs and on the speed scale of the Integrated Standby Instrument System (ISIS). This was because the measured airspeed from all 3 ADRs was below 30 kt.
- **② From 50 kt to approximately 140 kt of ground speed:** The **SPD** red flag was displayed on the speed scale of both PFDs and the IAS on the ISIS was still at the bottom of the speed scale.
- **③ From 140 kt of ground speed until rotation and liftoff:** The IAS was between 30 kt and 50 kt on at least one of the PFDs. The IAS of the ISIS remained at the bottom of the speed scale.

(*) This type of flight data recorder records only the airspeed value of the captain's side, provided it is valid information. Otherwise, it will record the first officer's IAS. The IAS may have been displayed on both PFDs at this stage. If it was only displayed on one PFD, the other PFD would still have displayed the SPD red flag.

This sequence is in accordance with the display logic of the IAS on the PFD:

- If the measured airspeed is below 30 kt and ground speed is below 50 kt, then the IAS remains at the bottom of the speed scale
- If the measured airspeed is below 30 kt and the ground speed is above 50 kt, the **SPD** red flag is displayed on the speed scale
- When the measured airspeed is above 30 kt, it will be displayed on the PFD. ■

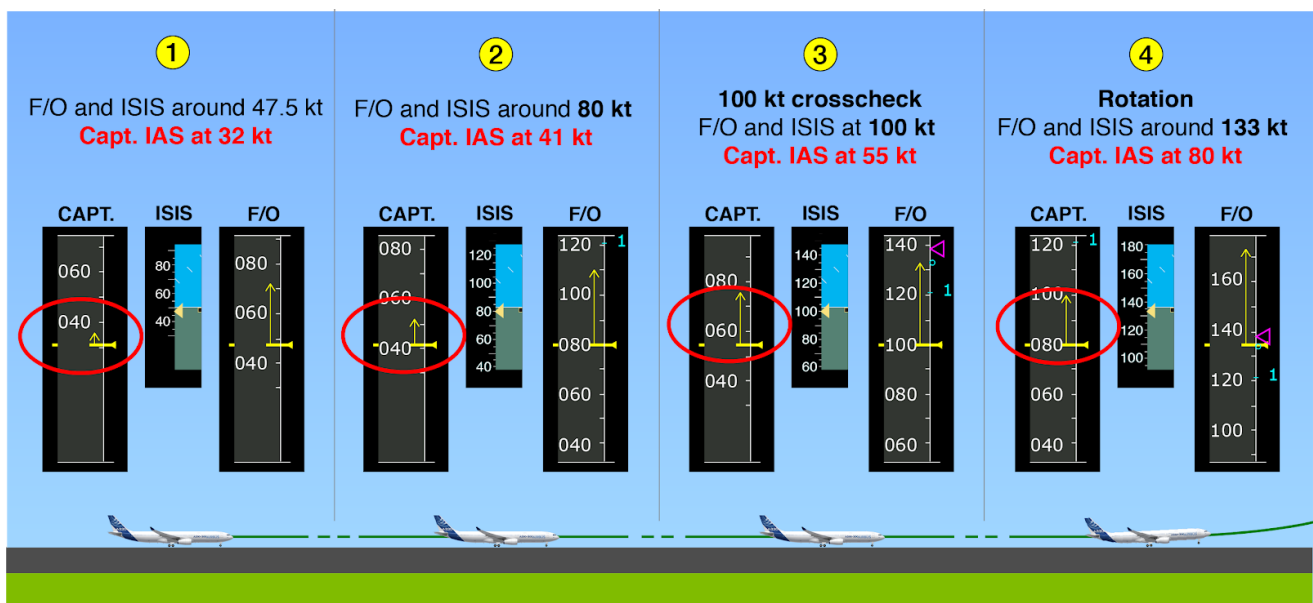
(fig.3) PFD airspeed indication during the takeoff roll of the event

Flight data recorder analysis confirmed the effects caused by the obstruction of the captain's Pitot probe.

If the airspeed was monitored even more closely by the flight crew during the takeoff roll, they may have identified the speed discrepancy sooner, allowing them to reject the takeoff and bring the aircraft safely to a stop.

- ① The IAS remained at the bottom of the PFD speed scale on both PFDs, and on the ISIS, at the start of the takeoff roll until the measured speed reached 30 kt (which is its normal behavior). The captain's IAS went above 30 kt when the first officer and ISIS IAS both indicated approximately 47 kt.
- ② When the first officer and ISIS IAS indicated approximately 80 kt, the captain's IAS was only displaying 41 kt.
- ③ When the first officer and ISIS IAS indicated 100 kt, the captain's IAS was only displaying approximately 55 kt.
- ④ The captain rotated the aircraft when 133 kt was indicated on the first officer's PFD and ISIS, but the captain's IAS was only displaying 80 kt. ■

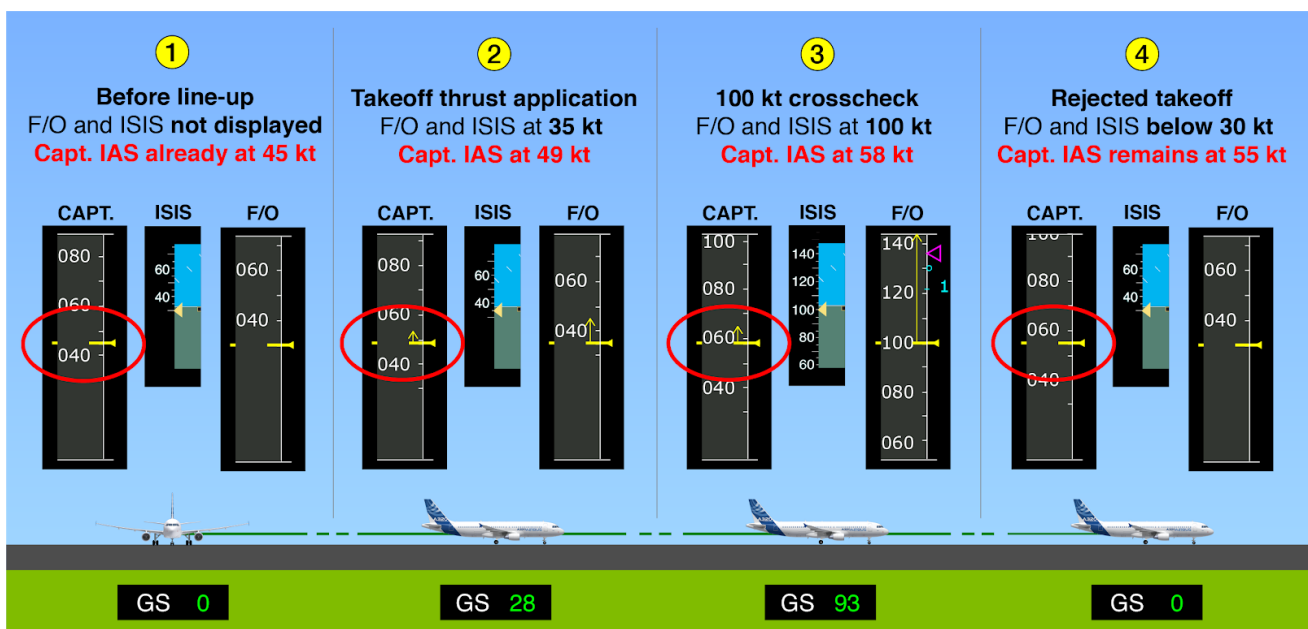
(fig.4) PFD airspeed indication during the takeoff roll of the event

- ① Recorder data showed that obstruction of the captain's Pitot probe was providing an initial IAS of approximately 45 kt while the aircraft Ground Speed (GS) was 0 kt prior to the aircraft lining up on the runway.
- ② At the application of takeoff thrust, the first officer and ISIS IAS indicated 35 kt with nominal acceleration shown by the speed trend arrow on the first officer's PFD. However, the IAS on the captain's PFD was 49 kt with a very small speed trend arrow.
- ③ When 100 kt was reached on the first officer's PFD and ISIS, the captain's IAS was only 58 kt.
- ④ When the aircraft safely came to a complete stop after the RTO, the captain's IAS was still at 55 kt.

During the entire takeoff roll, the captain's IAS increased slightly but remained below 64 kt. The 100 kt crosscheck enabled the captain to identify the discrepancy and immediately reject the takeoff.

The Standard Operating Procedure requests monitoring of the PFD speed scale during the entire takeoff roll. Following this recommendation may have made the flight crew aware of the airspeed discrepancy earlier than the 100 kt callout and enabled them to reject the takeoff at lower speed. The first opportunity to detect the speed discrepancy was before lining up for takeoff, when the captain's airspeed indicated 45 kt while the aircraft was stationary with ground speed at 0 kt. The second opportunity was at the application of takeoff thrust when the IAS on the captain's PFD was almost steady speed with a very small speed trend arrow. ■
