Unreliable Airspeed at Takeoff

Since the beginning of 2020, Airbus has received an increasing number of reports of unreliable airspeed events at takeoff due to Pitot probe obstruction. Despite the existing prevention means and the preflight exterior walkaround, takeoffs with obstructed air data probes may happen. This article highlights why it is so important for pilots to actively monitor the airspeed during the entire takeoff roll, to detect an airspeed discrepancy as early as possible, and safely reject the takeoff, if required to do so.

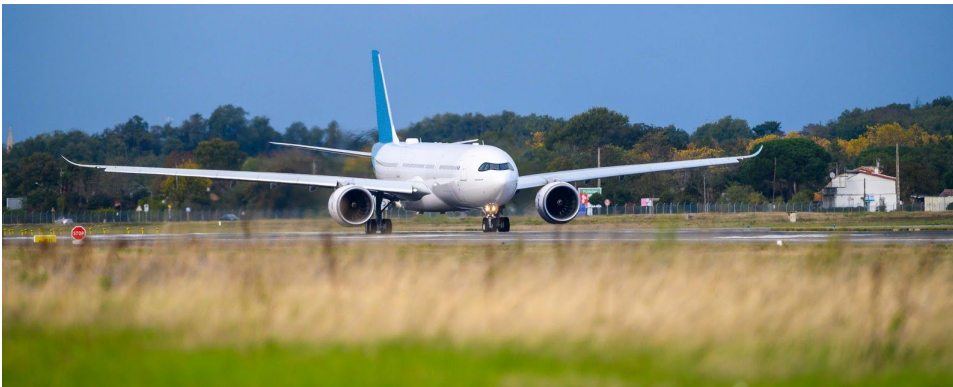
In 36 of the 55 reported cases, the flight crew detected the speed discrepancy and rejected the takeoff. For many of the reported rejected takeoffs, the speed discrepancy could have been detected earlier during the takeoff roll, which would have incited the flight crew to reject the takeoff at a lower speed. The following case studies of three events of unreliable airspeed at takeoff highlight the importance of speed monitoring during the takeoff roll. ■
